Tonawanda Creek/Erie Canal Hydrilla Control Demonstration Project

October 6, 2015

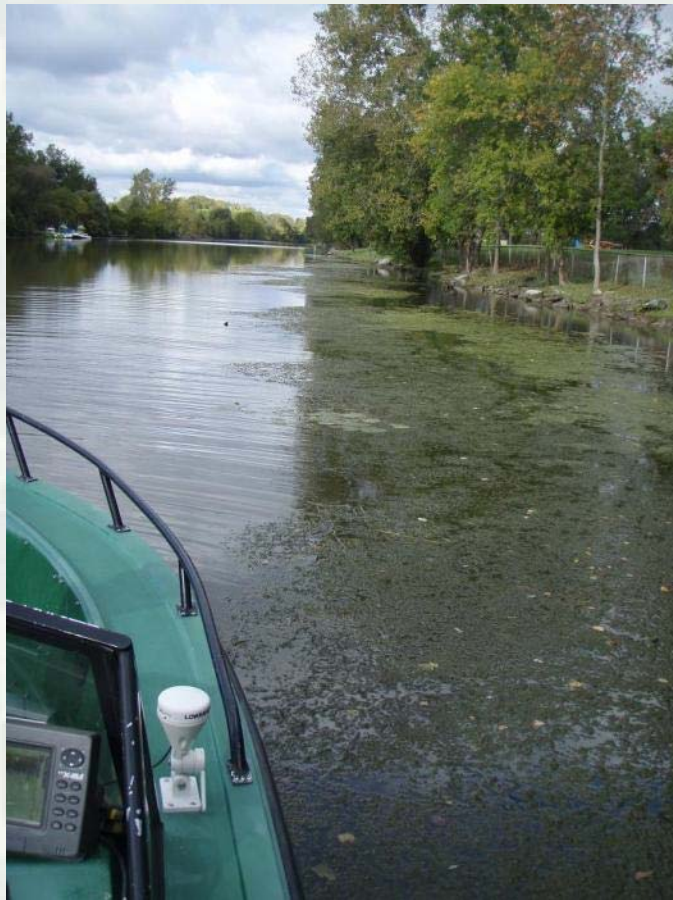
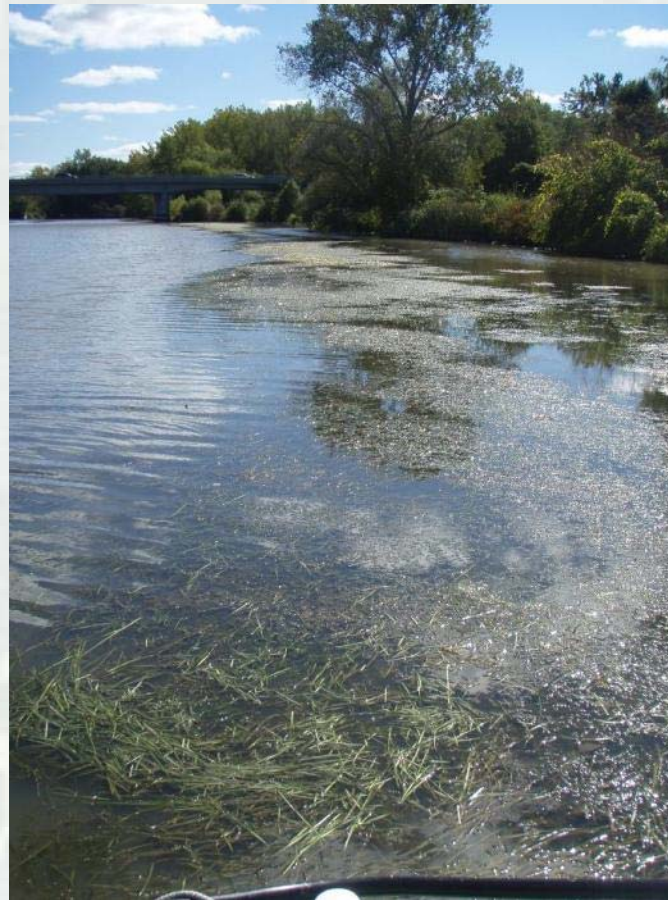
Hydrilla can be found in patchy large beds along the canal banks*

* 2014 Pre-treatment

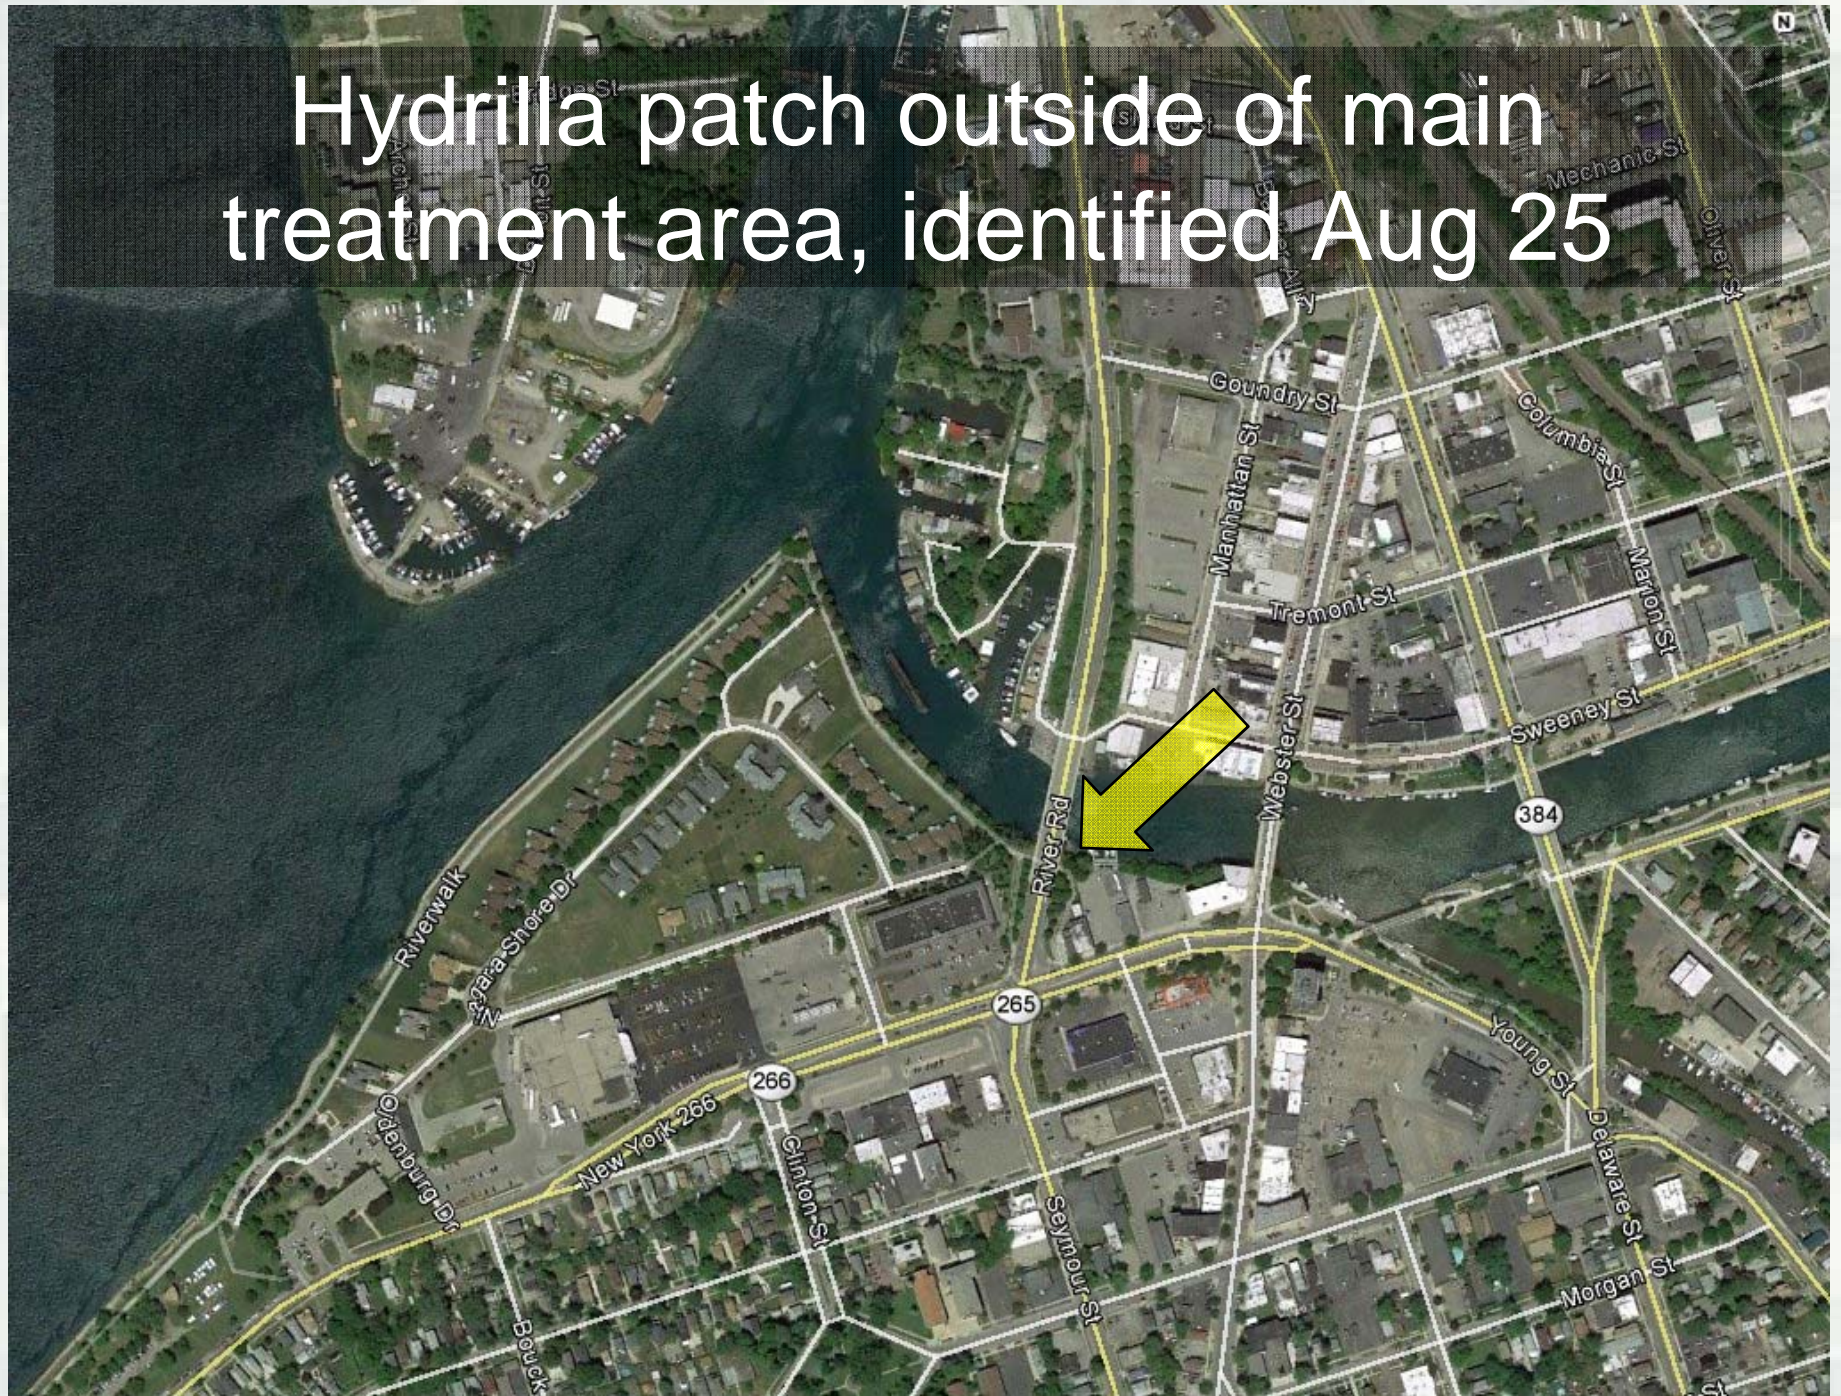
Hydrilla patch outside of main
treatment area, identified Aug 25

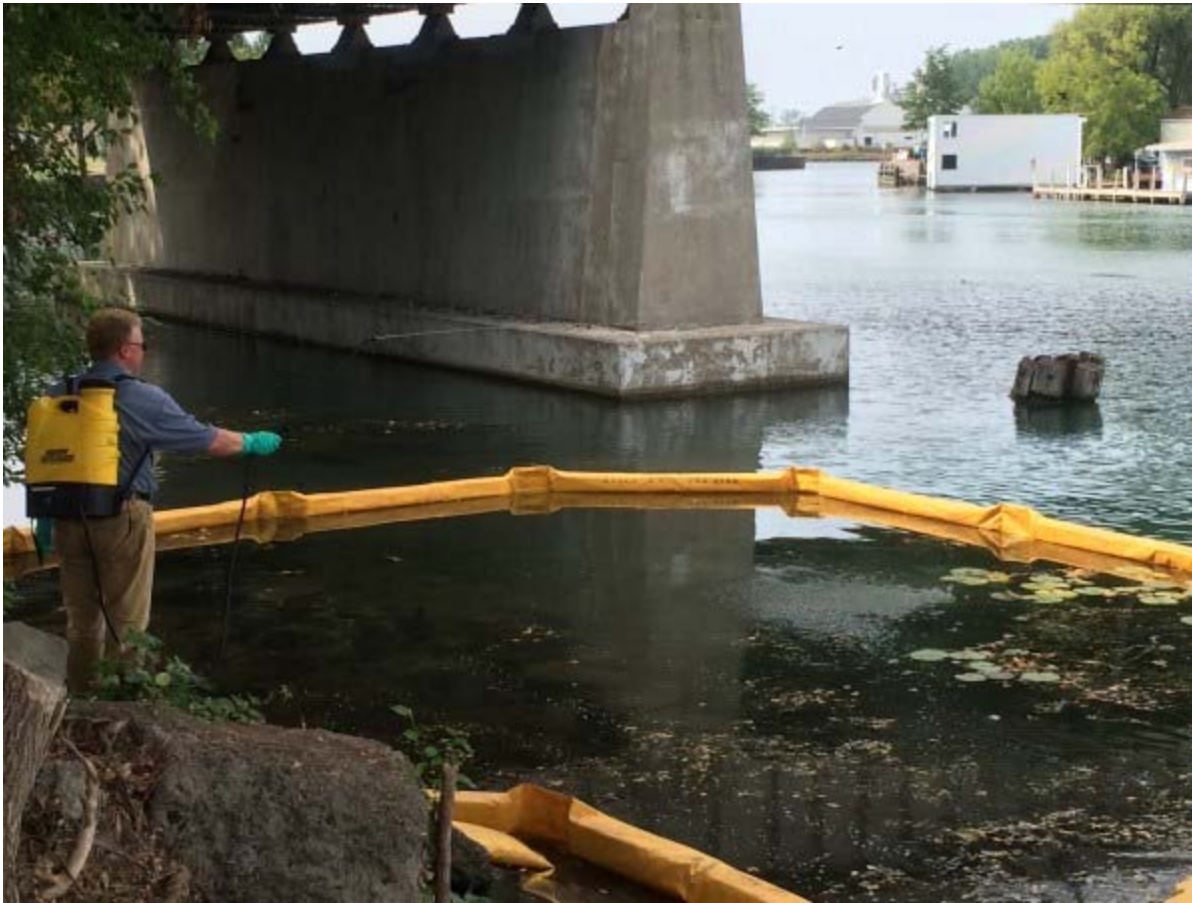
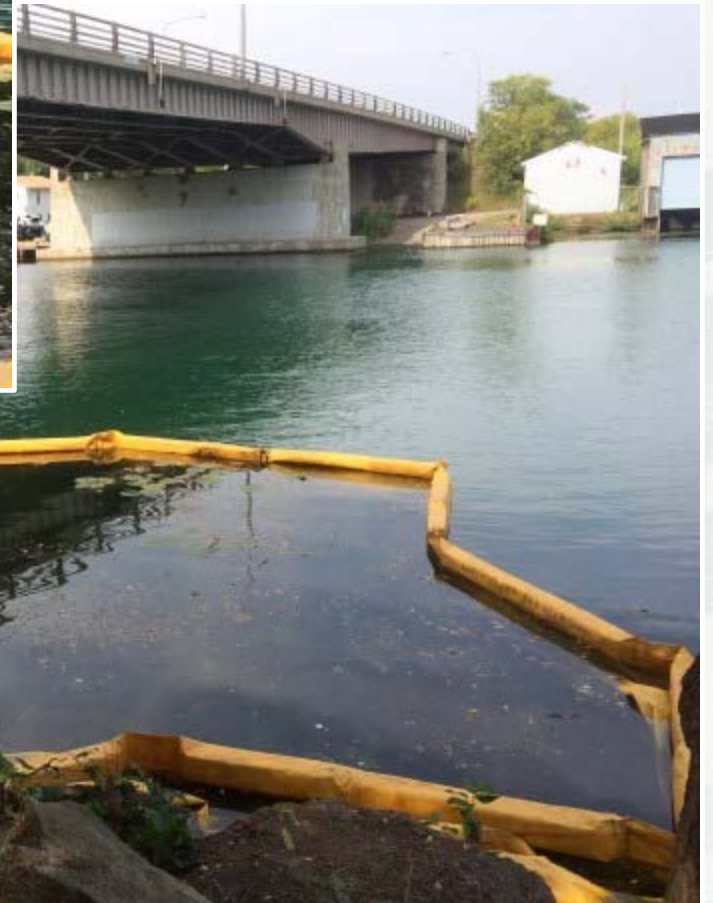
Spot herbicide application Sep 8 & 9
