Hydrilla in Illinois

2024 – Hydrilla Found - Ginger Creek – DuPage County

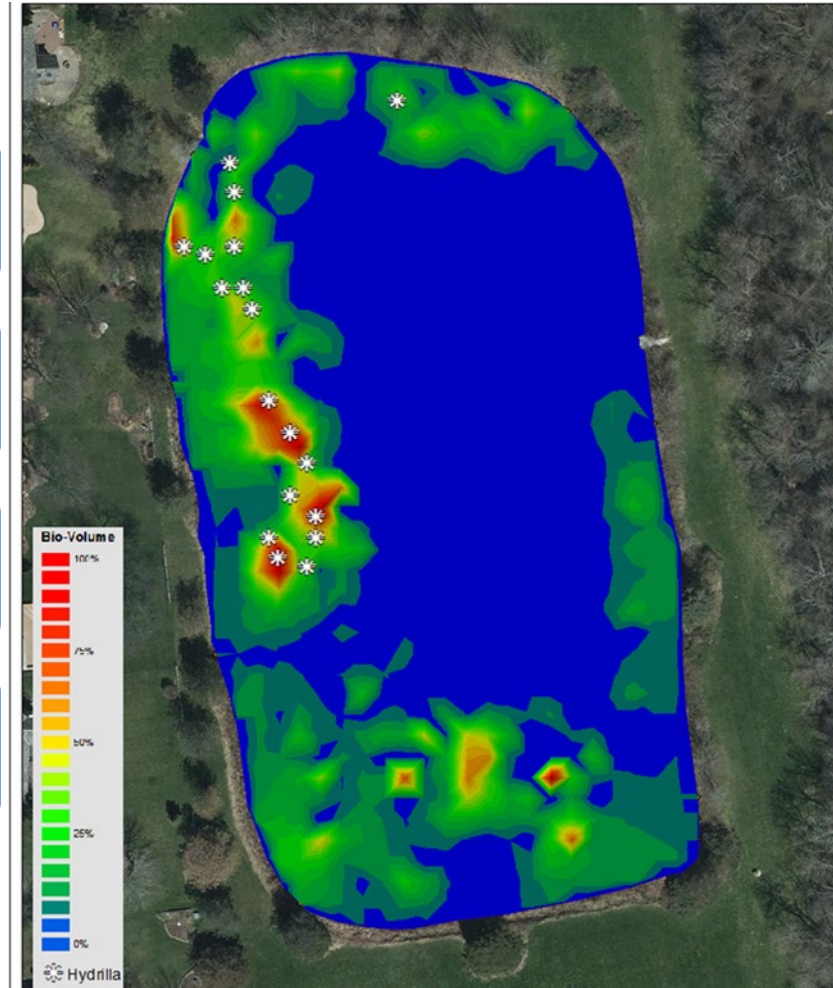
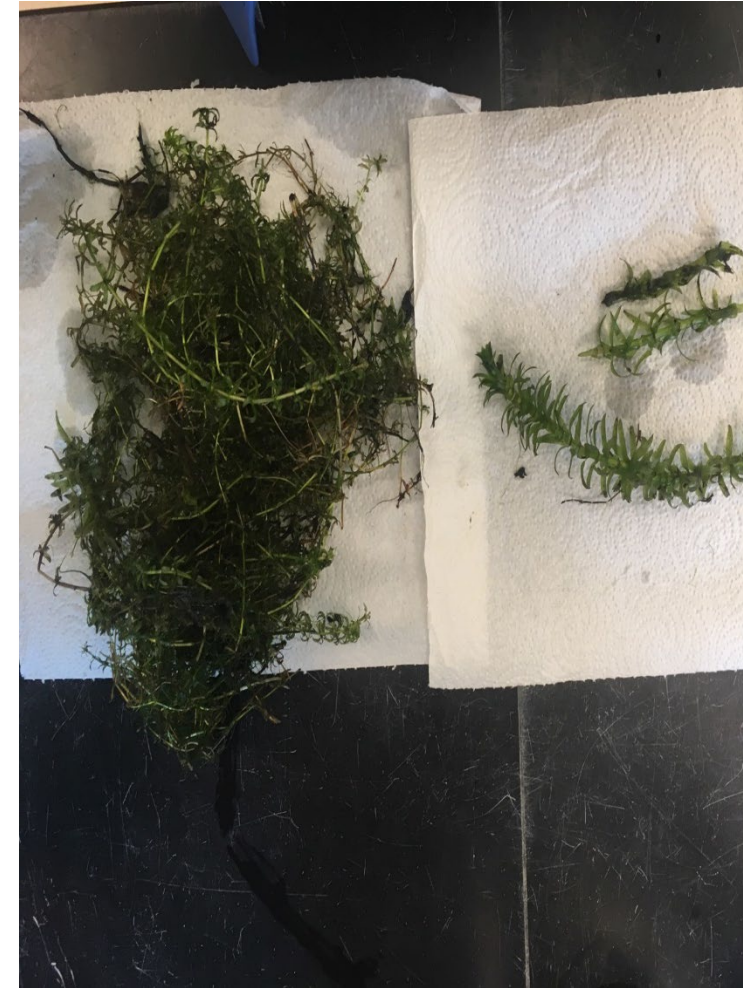
Hydrilla Found – July 2019 – Lake County

Commercial applicator – Identified

Other non-natives (Lillies, Brazilian Elodea)

Suspected Source: Aquarium/Water Garden

3 Acre Detention Pond – Outlet to Des Plaines River Backwaters (concern!)

- Multi Year Fluridone treatment
- Aquatic Plant Surveys in pond, nearby ponds, and river
- Outreach to residents (mailed letters and signage)

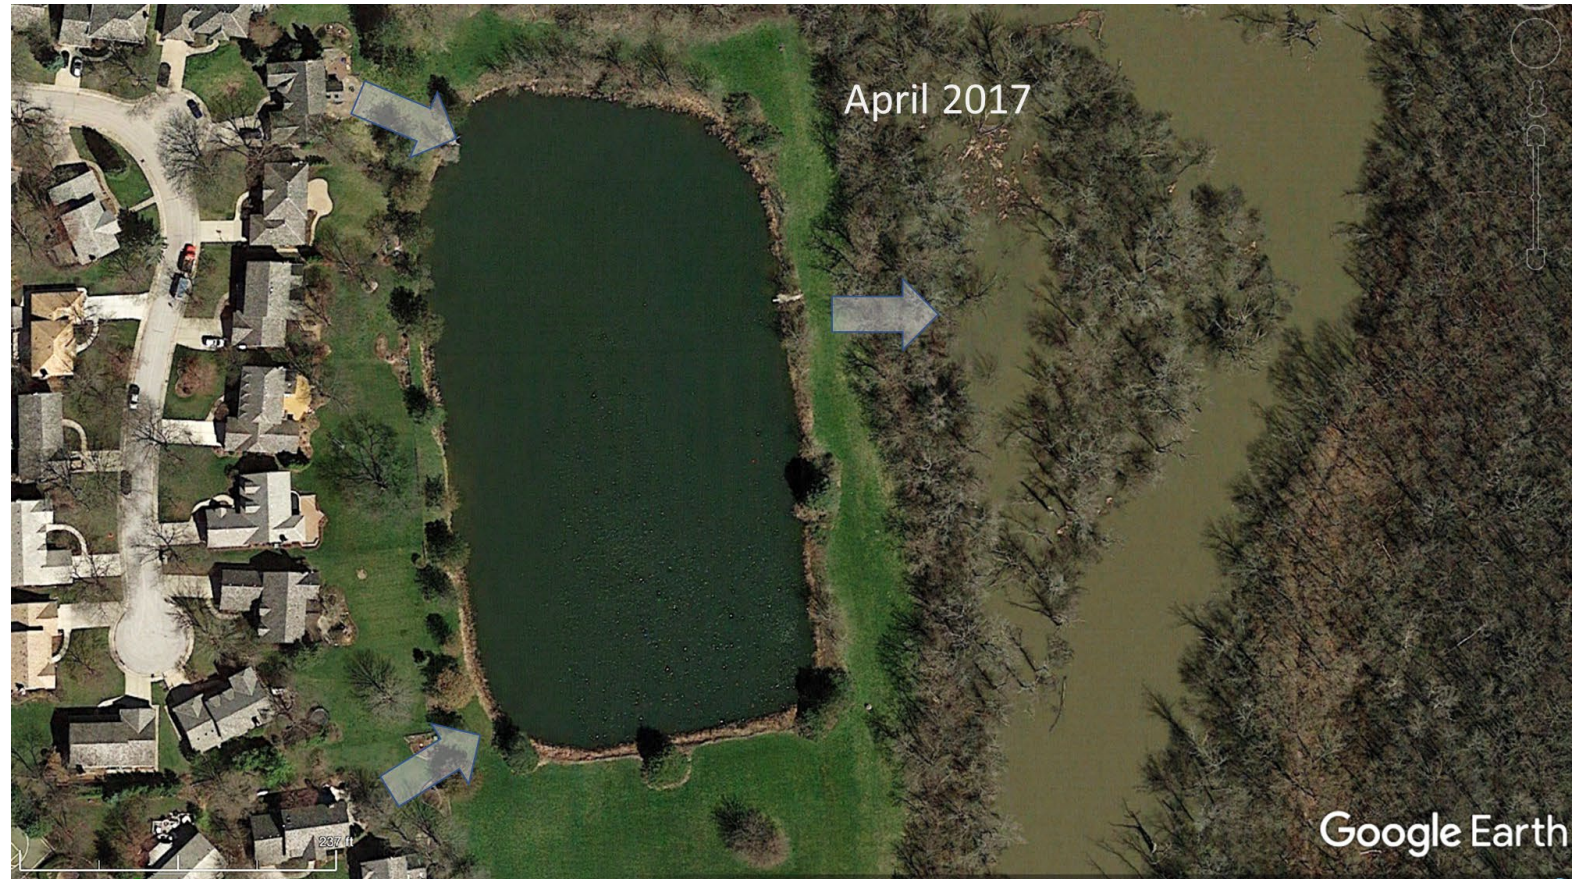
Hydrilla Found – July 2019 – Lake County

No Hydrilla has been re-observed.

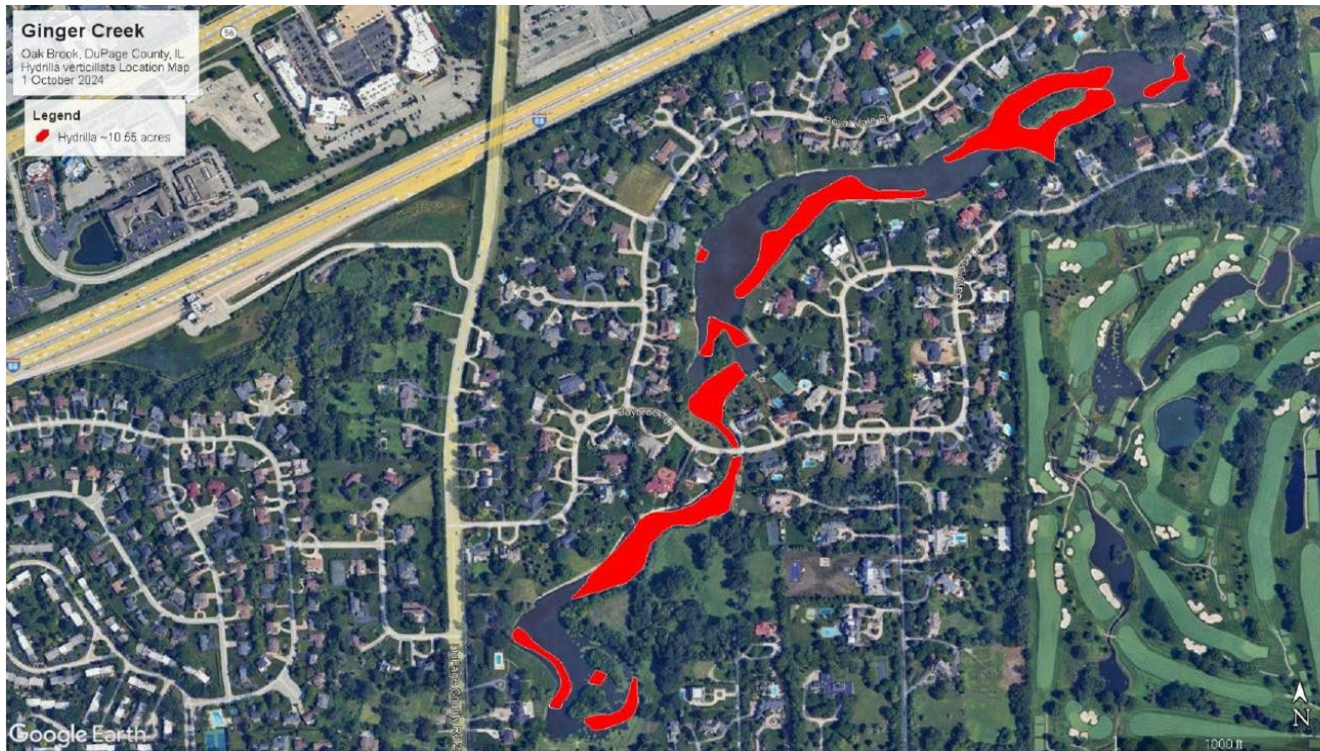
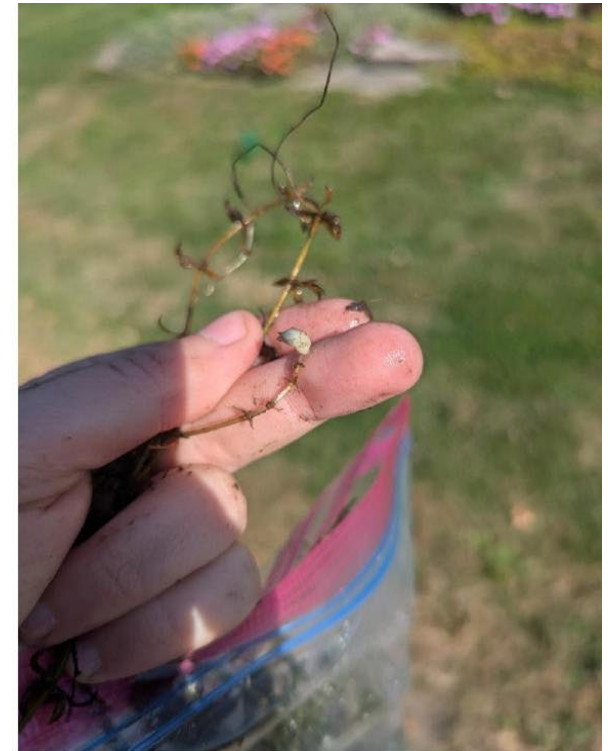
First identified by
private lake
consultant
October 2024.

10.5 acres Hydrilla
out of 26 acre lake

Sample verified by
IDNR

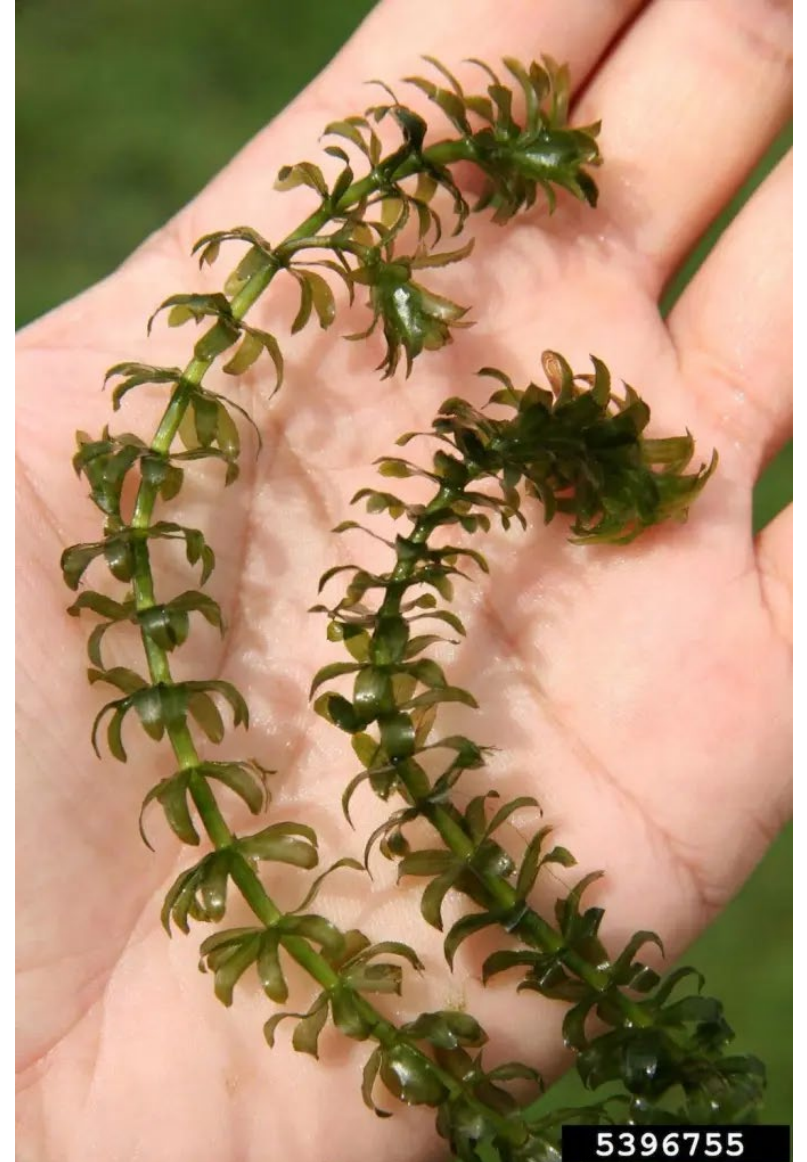
2024 – Hydrilla Found - Ginger Creek – DuPage County

Local agencies monitored downstream on Ginger Creek.

Hydrilla observed downstream of initial lake – spread is larger than suspected originally

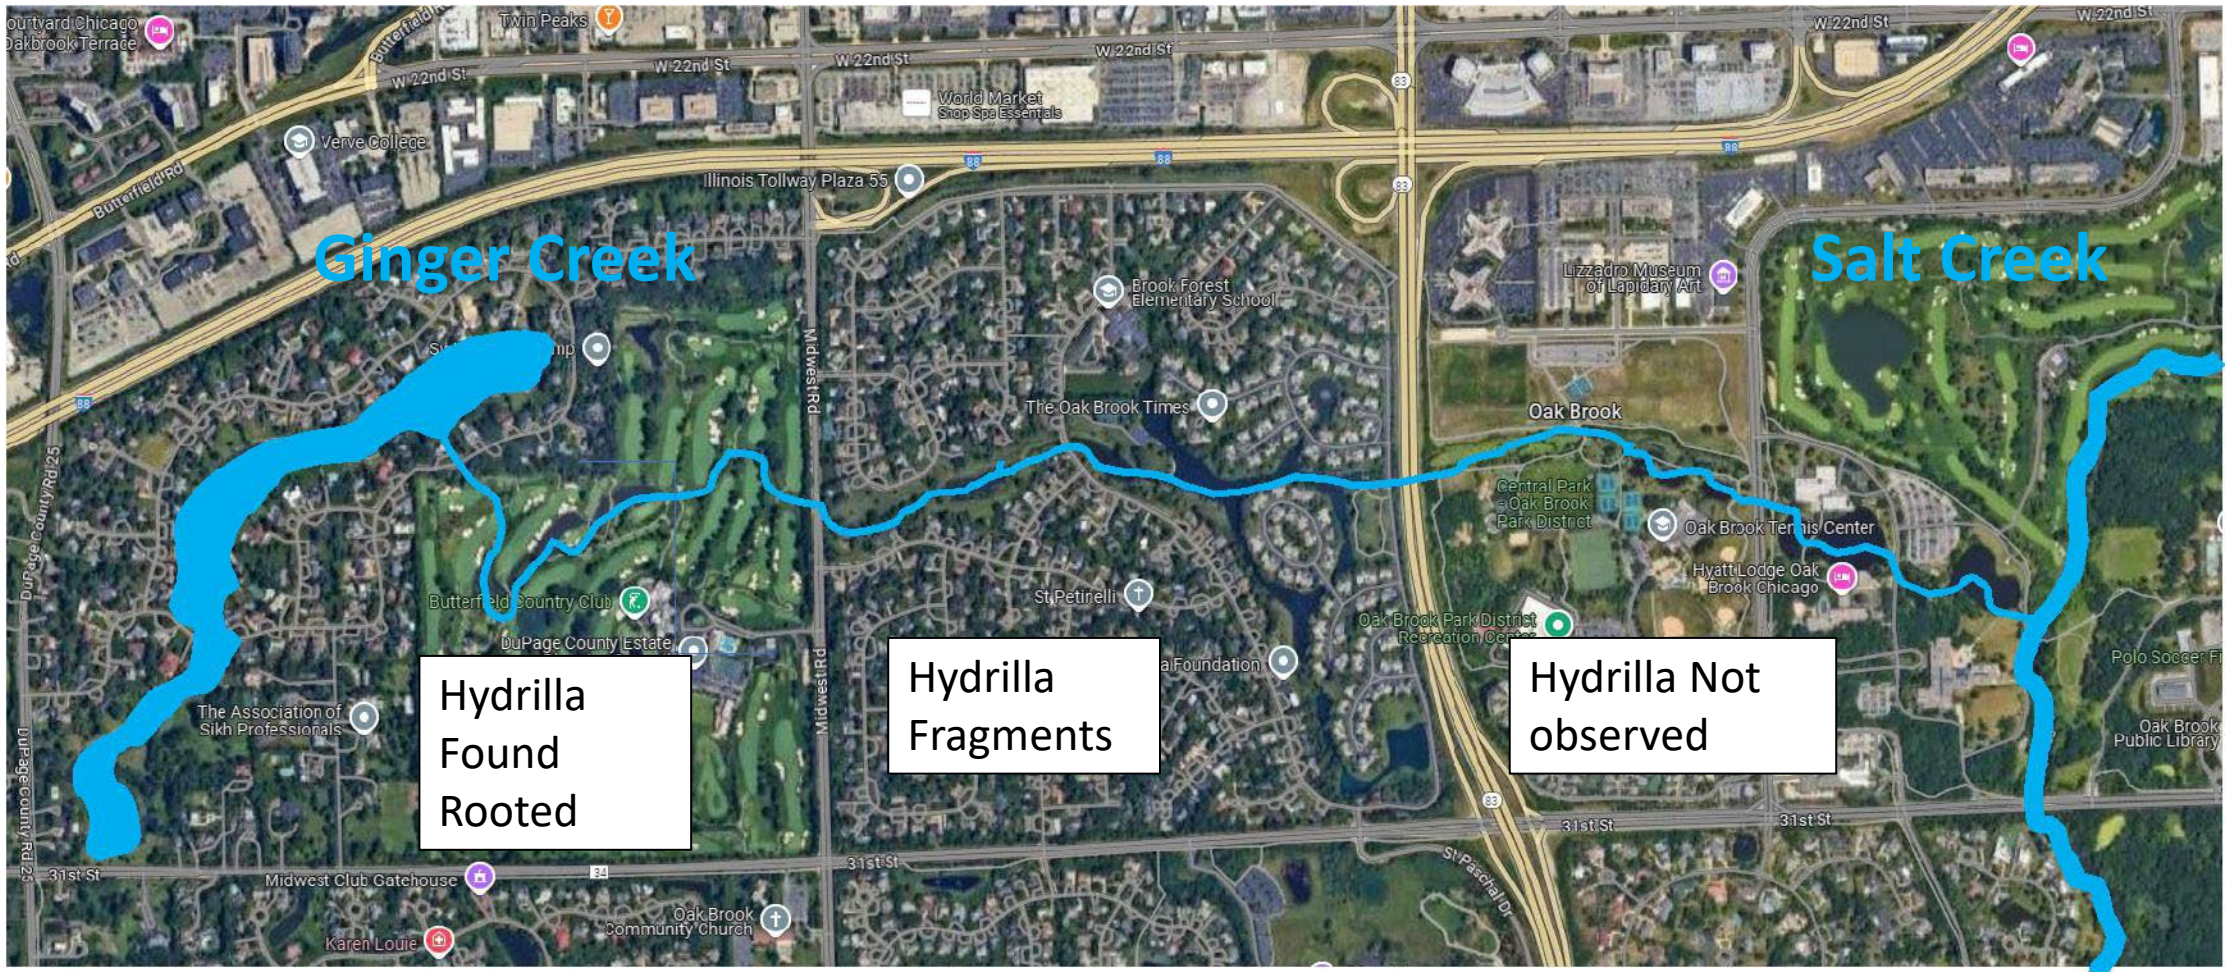
Hydrilla Assessments Downstream

2.5 miles from Ginger Creek HOA Lake to Salt Creek

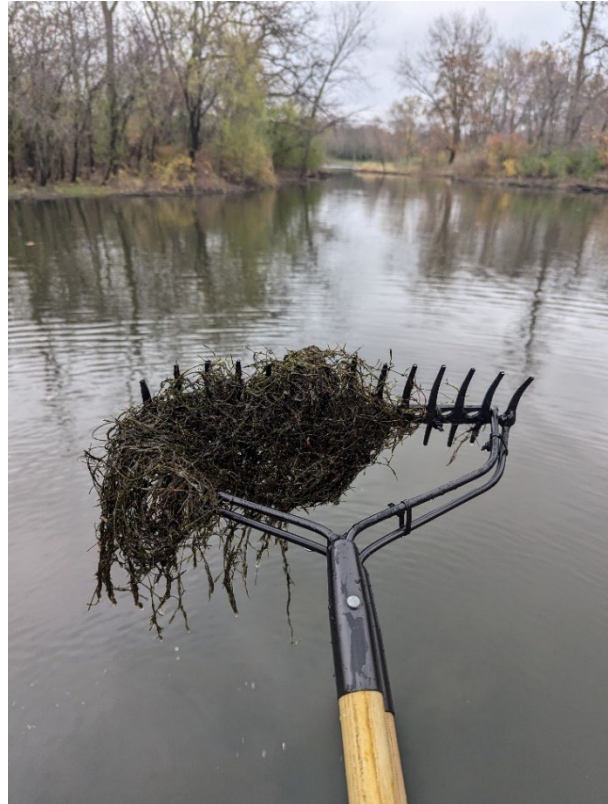
IDNR monitored
upstream on
Ginger Creek

Sampling took
place at the
detention basin
north of the I-88
inlet

No hydrilla was
found

Additional
upstream sampling
may be warranted
in 2025 when
temperatures are
more suitable for
growth

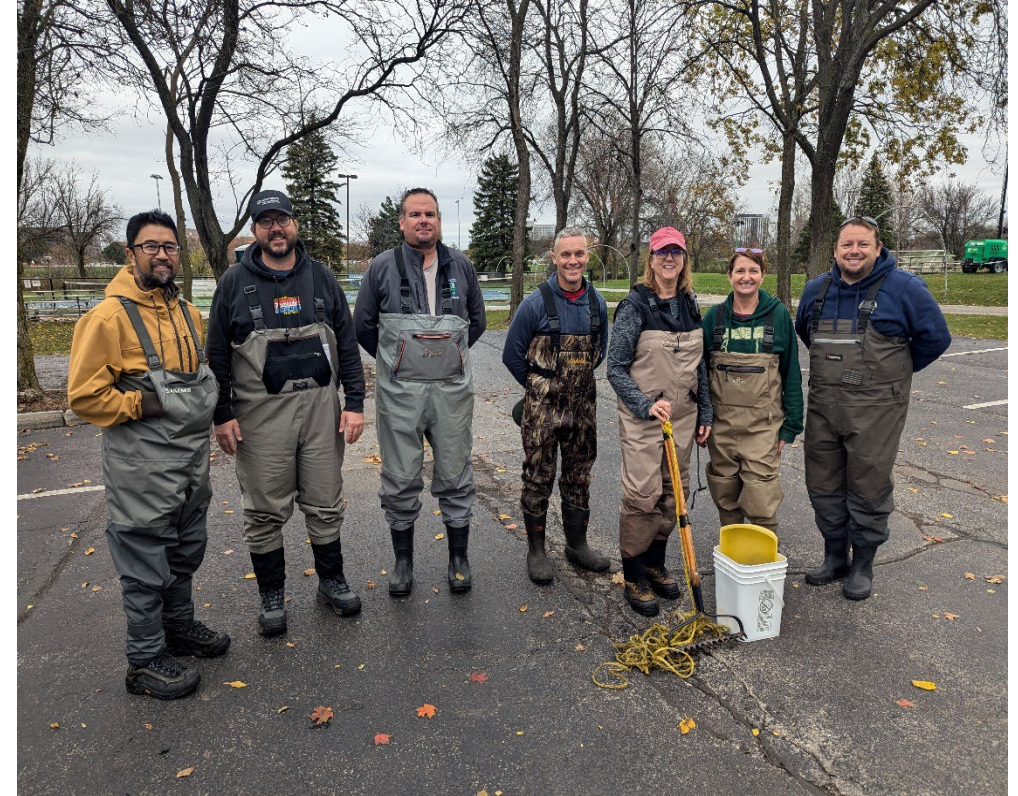
Plant rake used in sampling
finds naiad but no hydrilla

Sampling Nov 2024

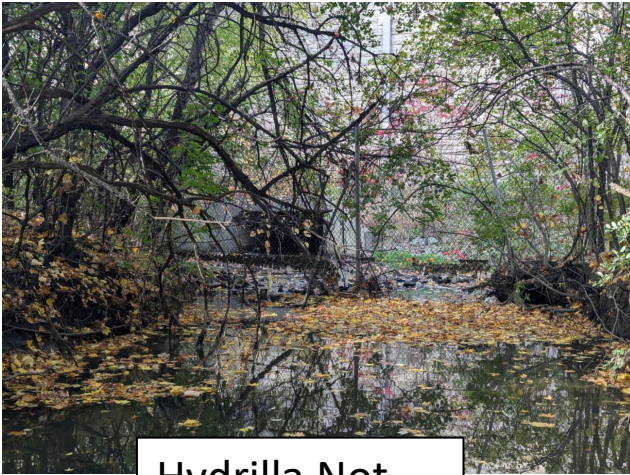
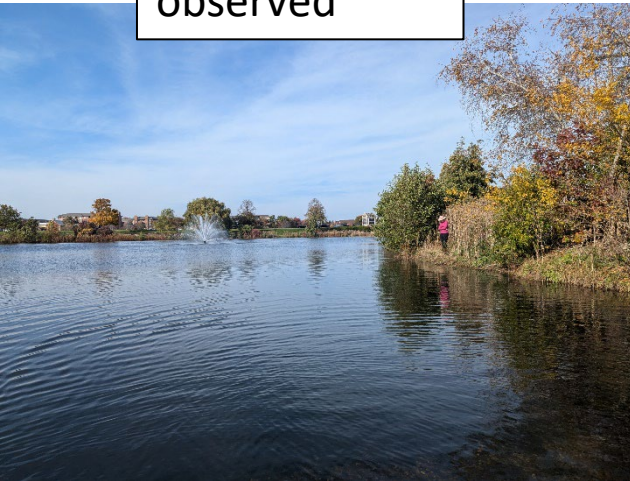
Inlet 1

Hydrilla Not
observed

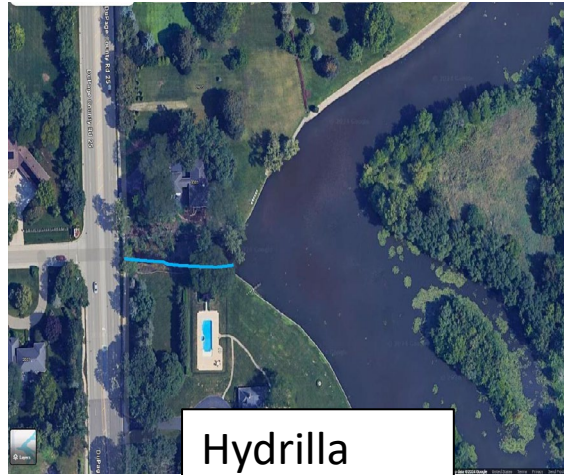
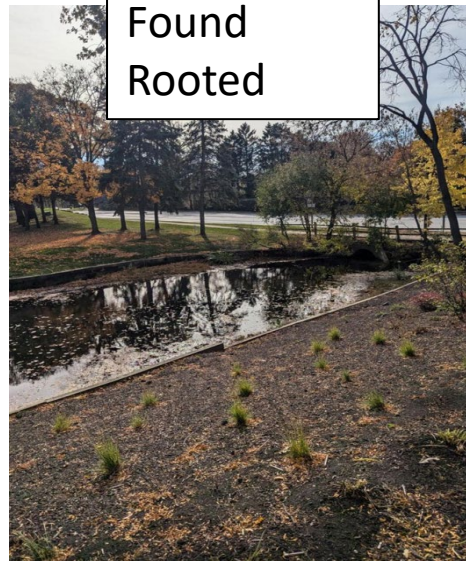
Inlet 2

Hydrilla
Found
Rooted

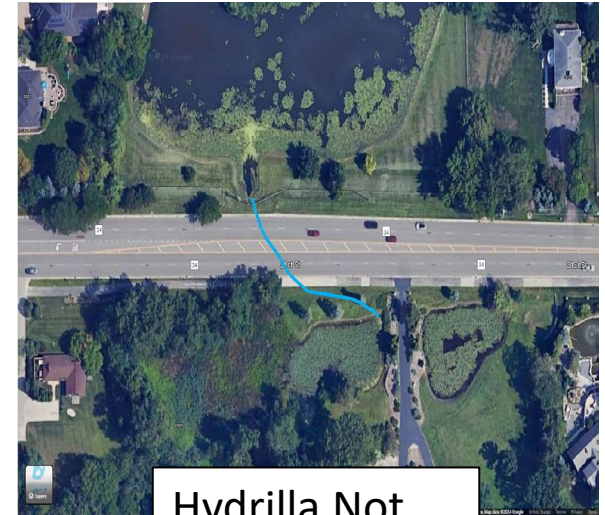
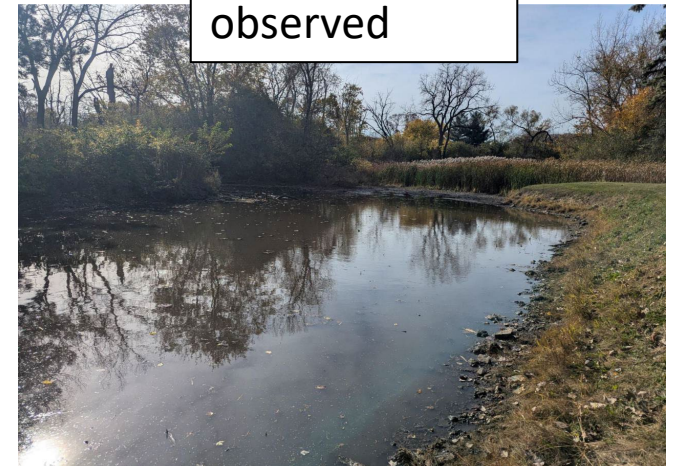
Inlet 3

Hydrilla Not
observed

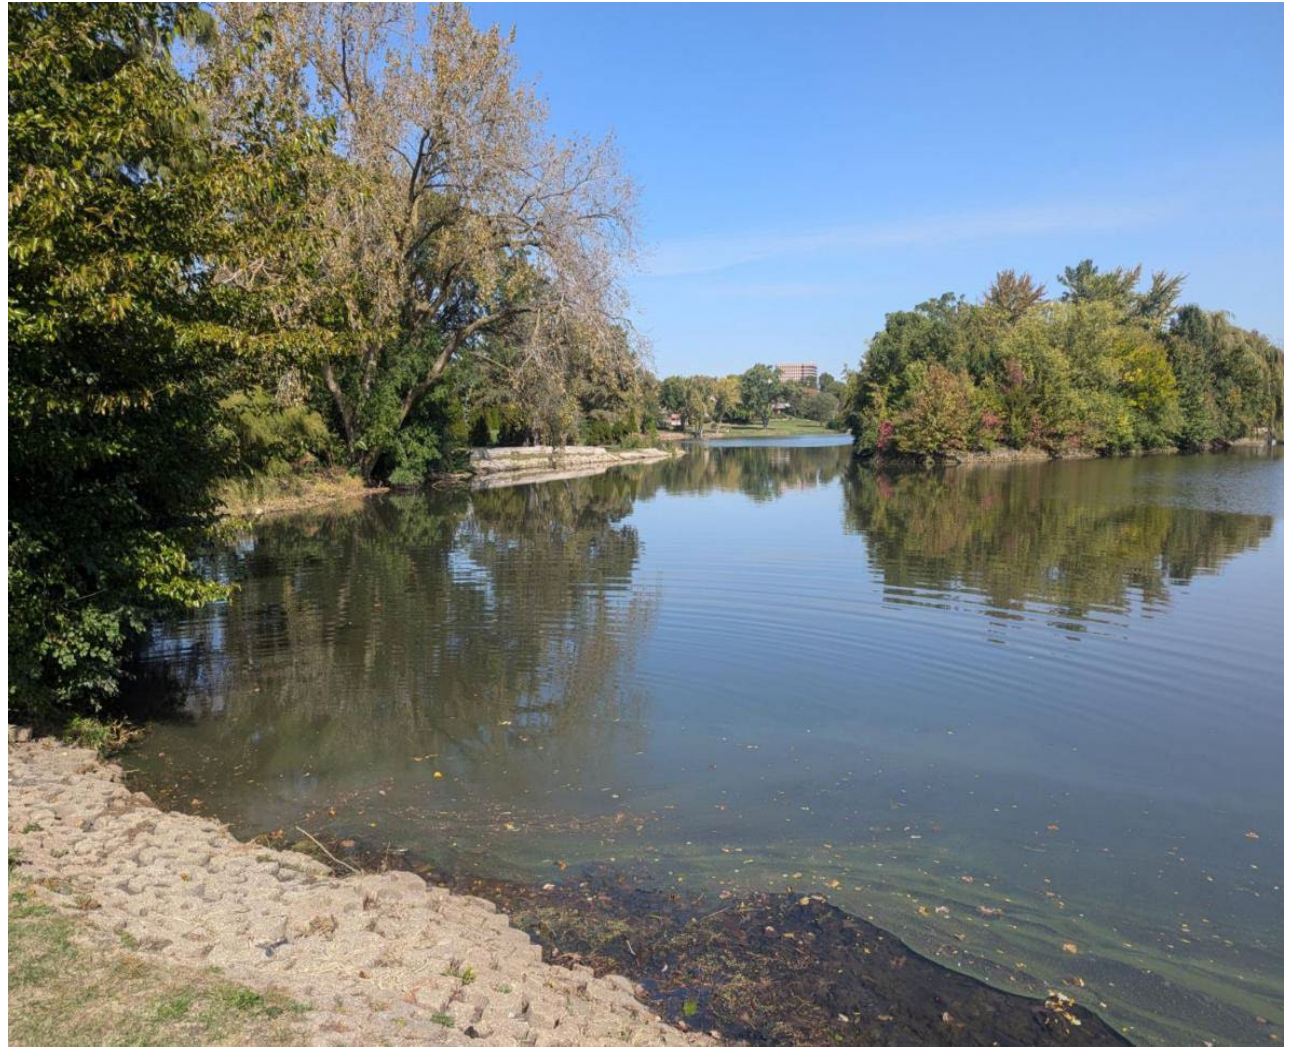
2024 – Hydrilla Found - Ginger Creek – DuPage County

- Drains to Salt Creek watershed
- Likely an aquarium or water garden release since Hydrilla, Brazilian Elodea and unidentified aquarium plant found.
- Has already spread downstream – not observed in Salt Creek
- Communication to properties have been initiated – more targeted communication and treatment plan is ongoing

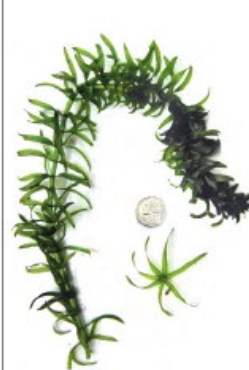
HYDRILLA

Hydrilla verticillata

- Whorls of **more than 3** leaves
- Leaves often have **visibly toothed** edge
- Leaf vein often has small **visible spines**

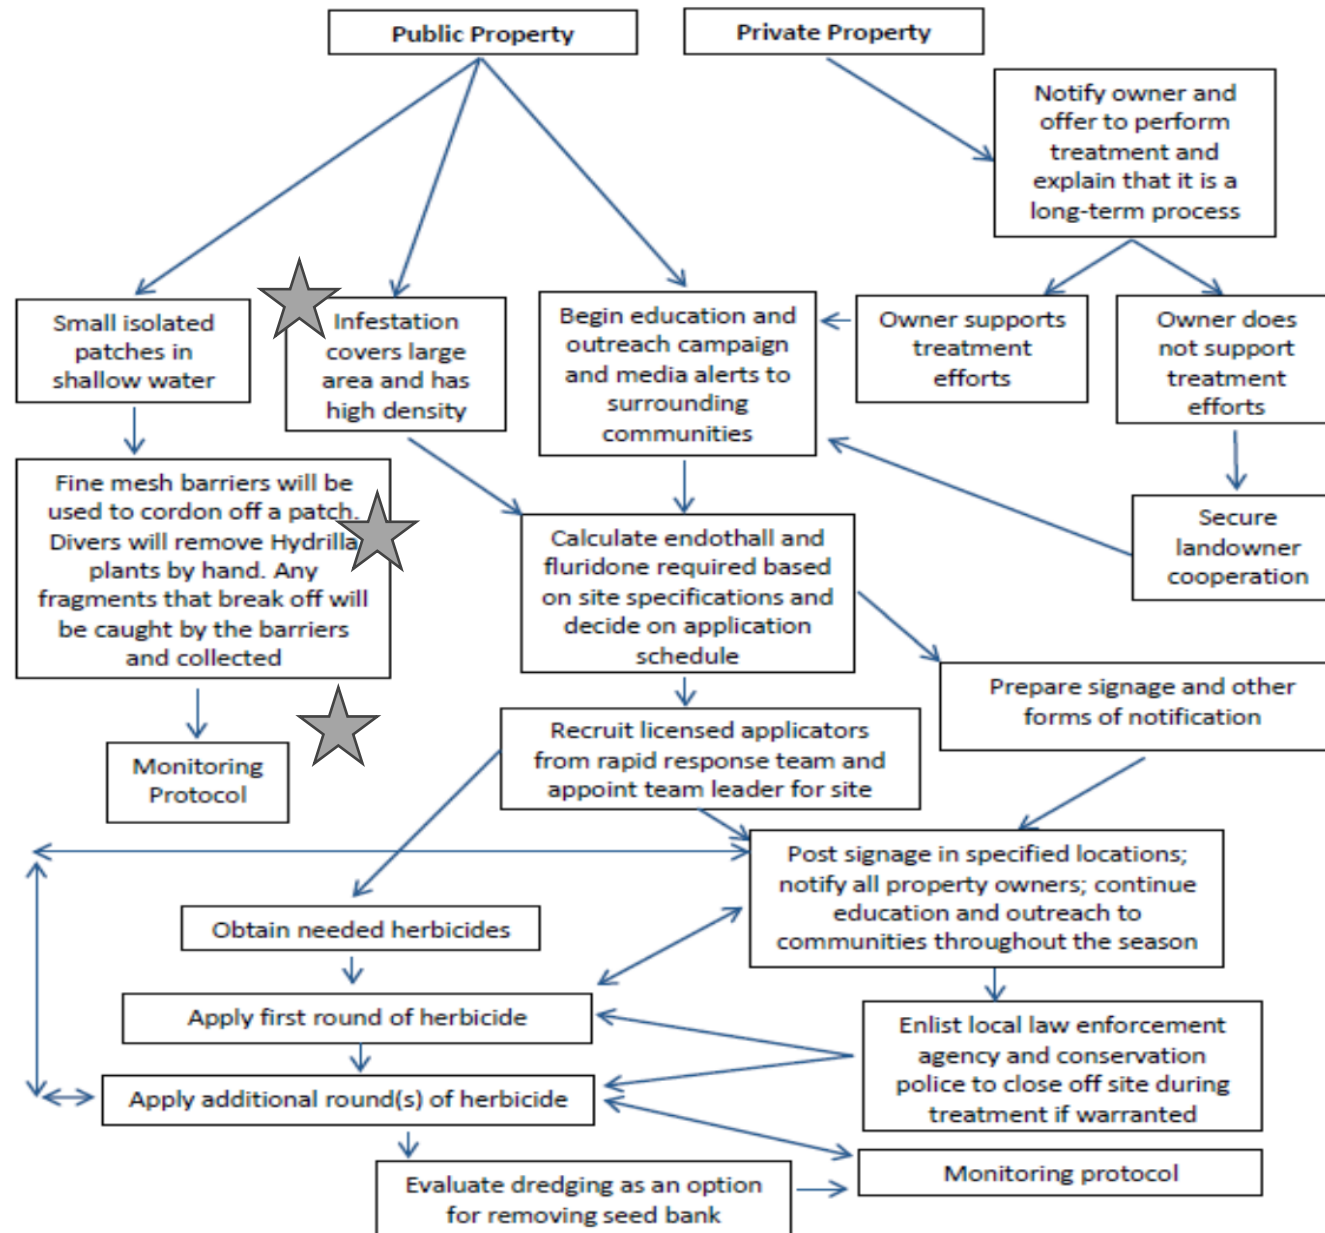
Treatment
planned for
Spring 2025

- Multi – Year Treatment & Monitoring
- ~80+ acres
- Aquatic Plant Surveys
- Inlet/Creek monitoring
- Tuber Monitoring
- Fluridone Treatments (Sonar One pellets for continuous release of active ingredient)
- Begin 10 ppb – target 3-5ppb throughout growing season.
