# Hydrilla Response in Michigan

May 14, 2026

Billy Keiper

EGLE Water Resources Division

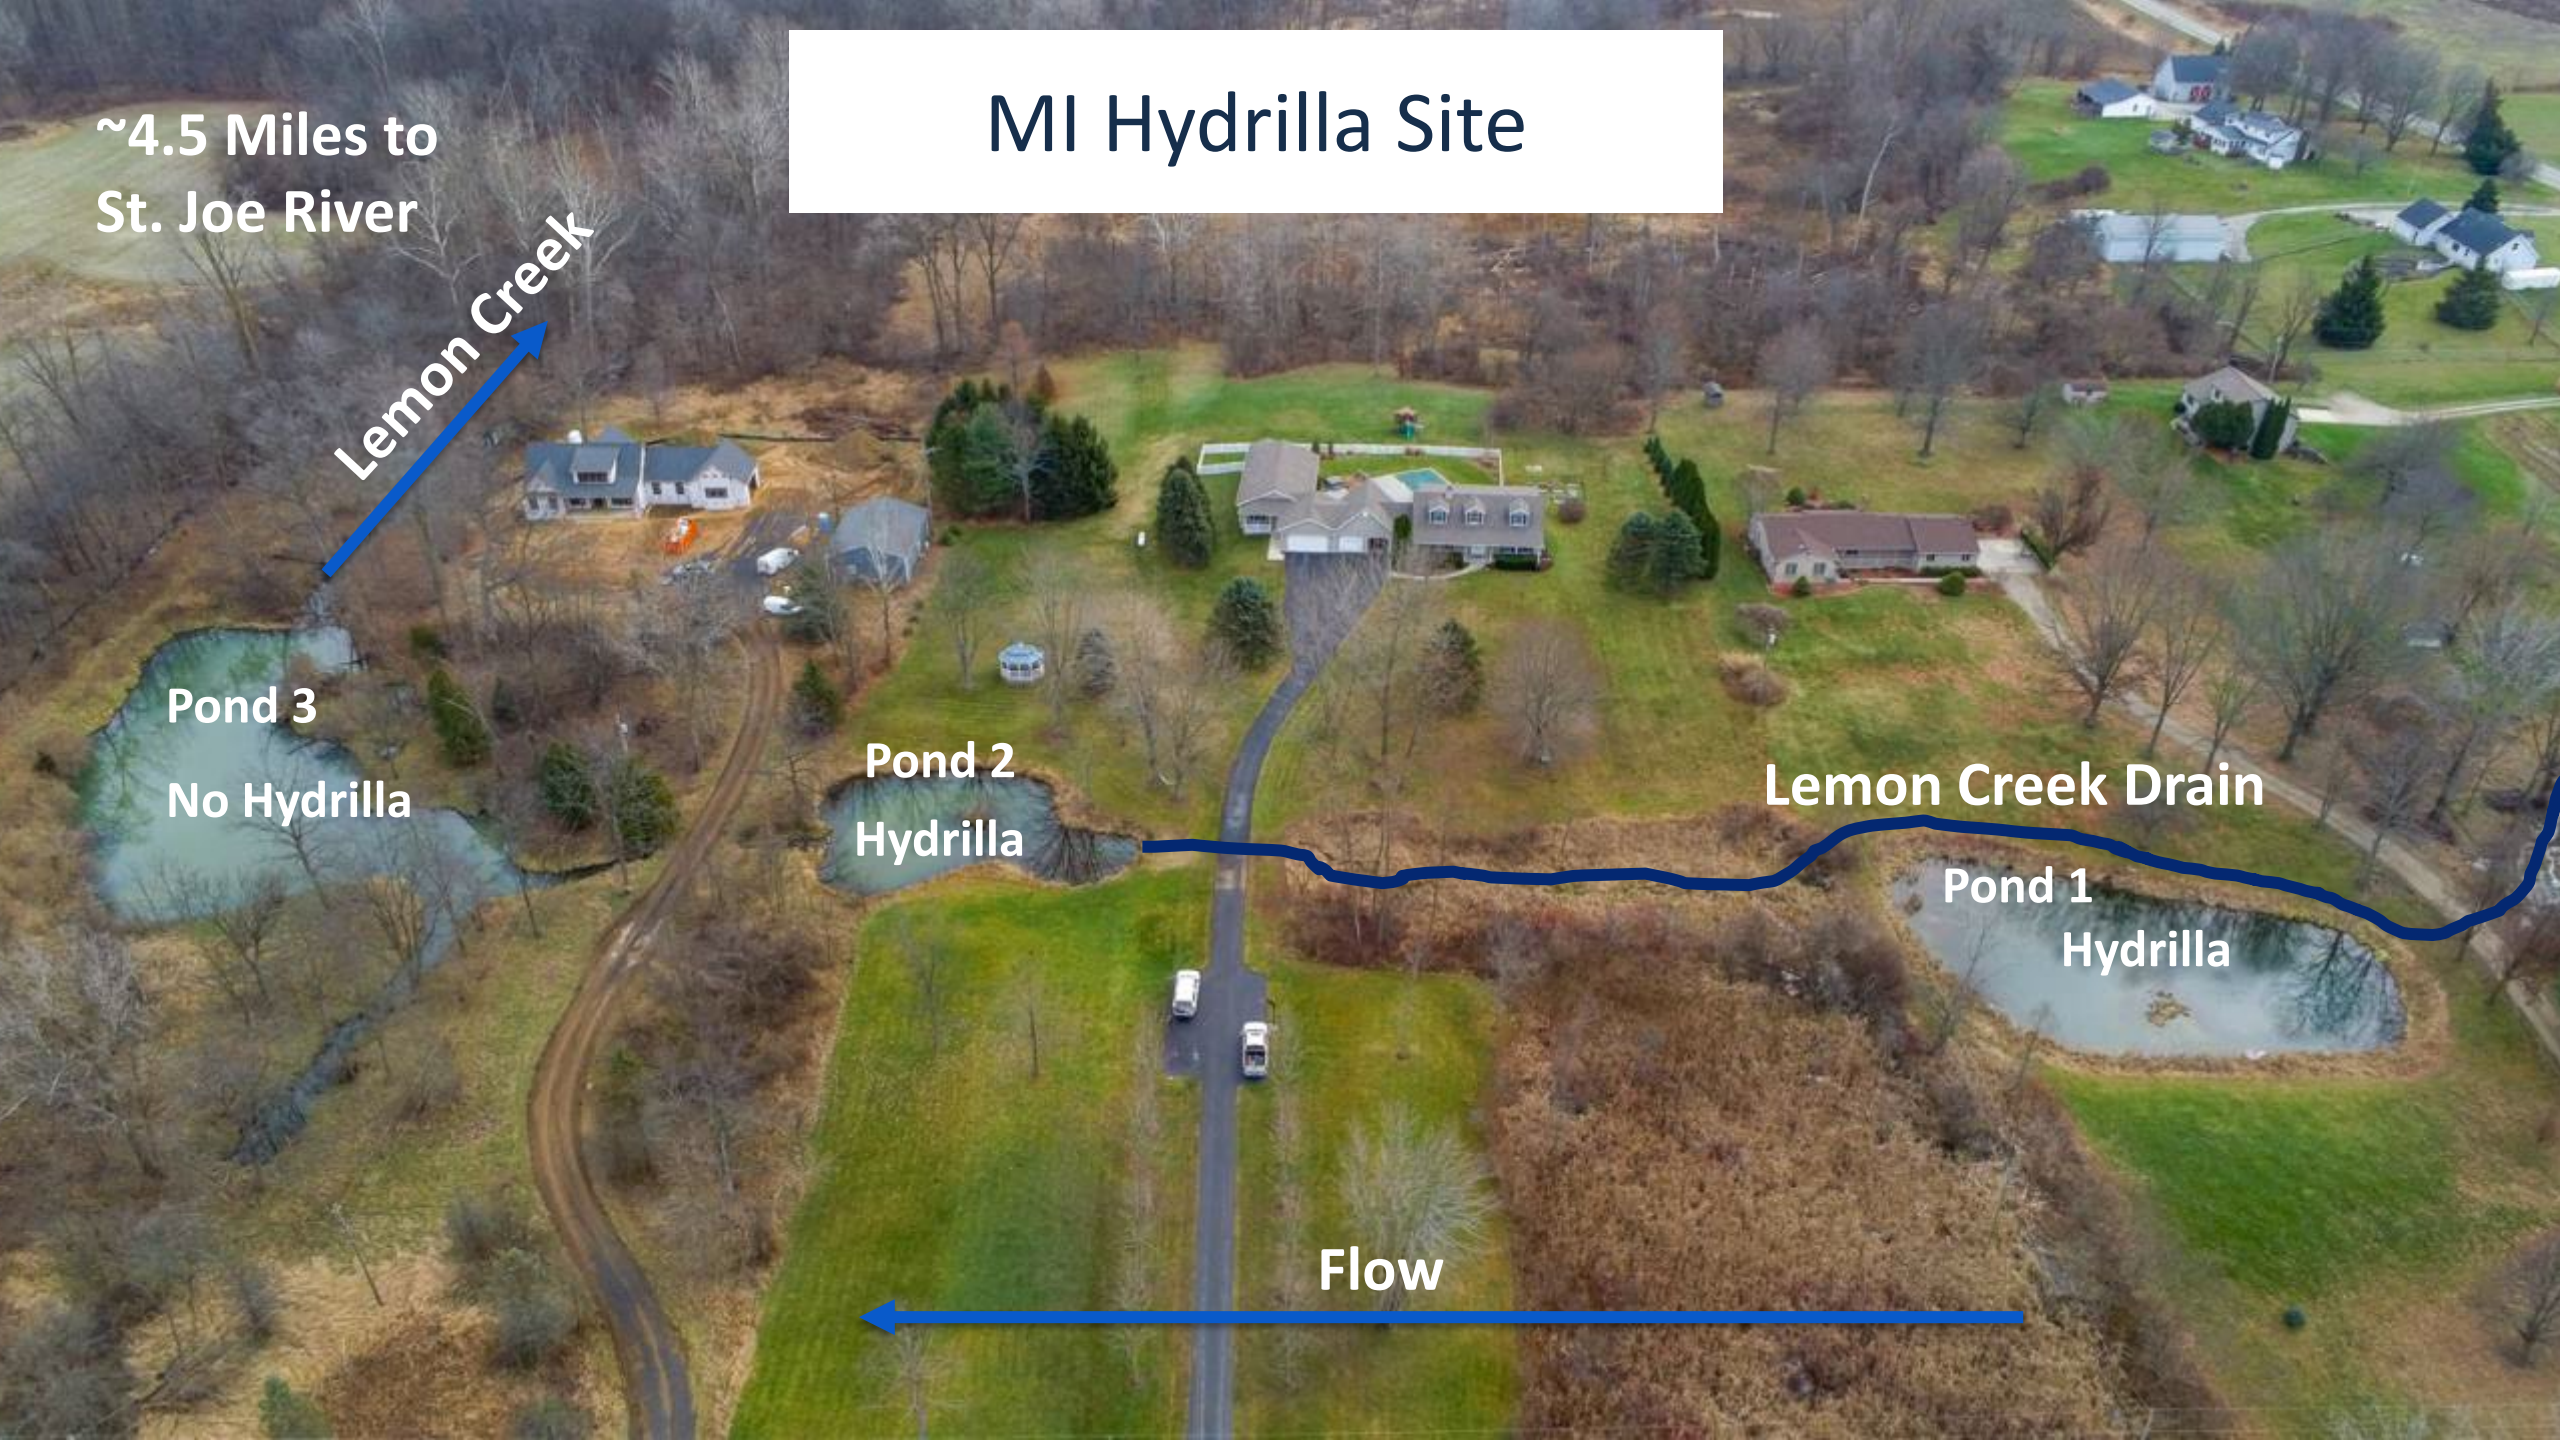
# MI Hydrilla Site

~4.5 Miles to  
St. Joe River

Lemon Creek

Pond 3  
No Hydrilla

Pond 2  
Hydrilla

Lemon Creek Drain

Pond 1  
Hydrilla

Flow

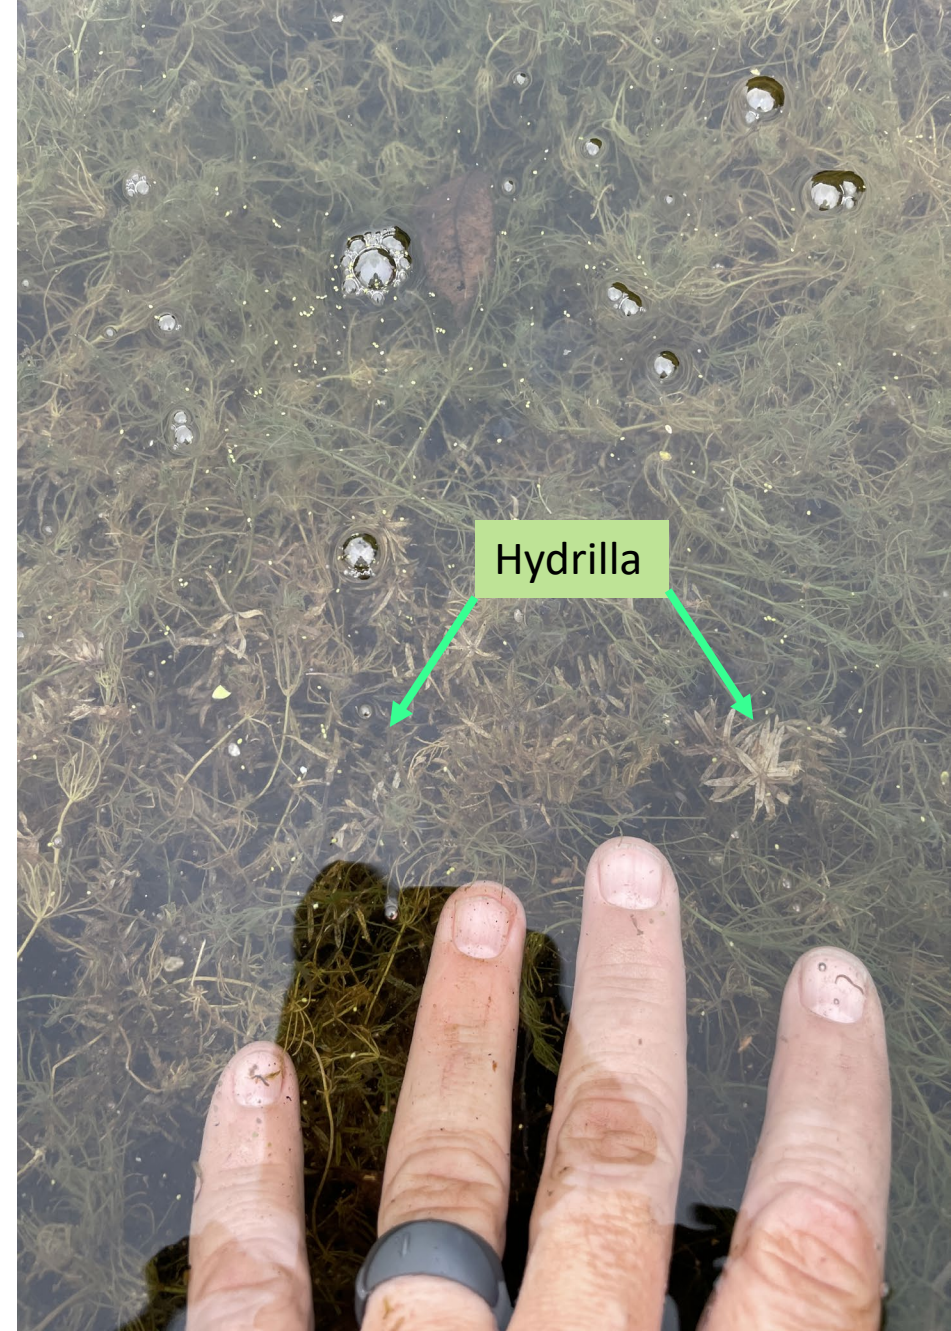
# Detection/delimitation

- Survey of ponds routinely: Monthly in growing season
- Survey Lemon Creek and St. Joe River annually
- Primarily in Pond 1, few hydrilla plants in Pond 2
- None in Pond 3

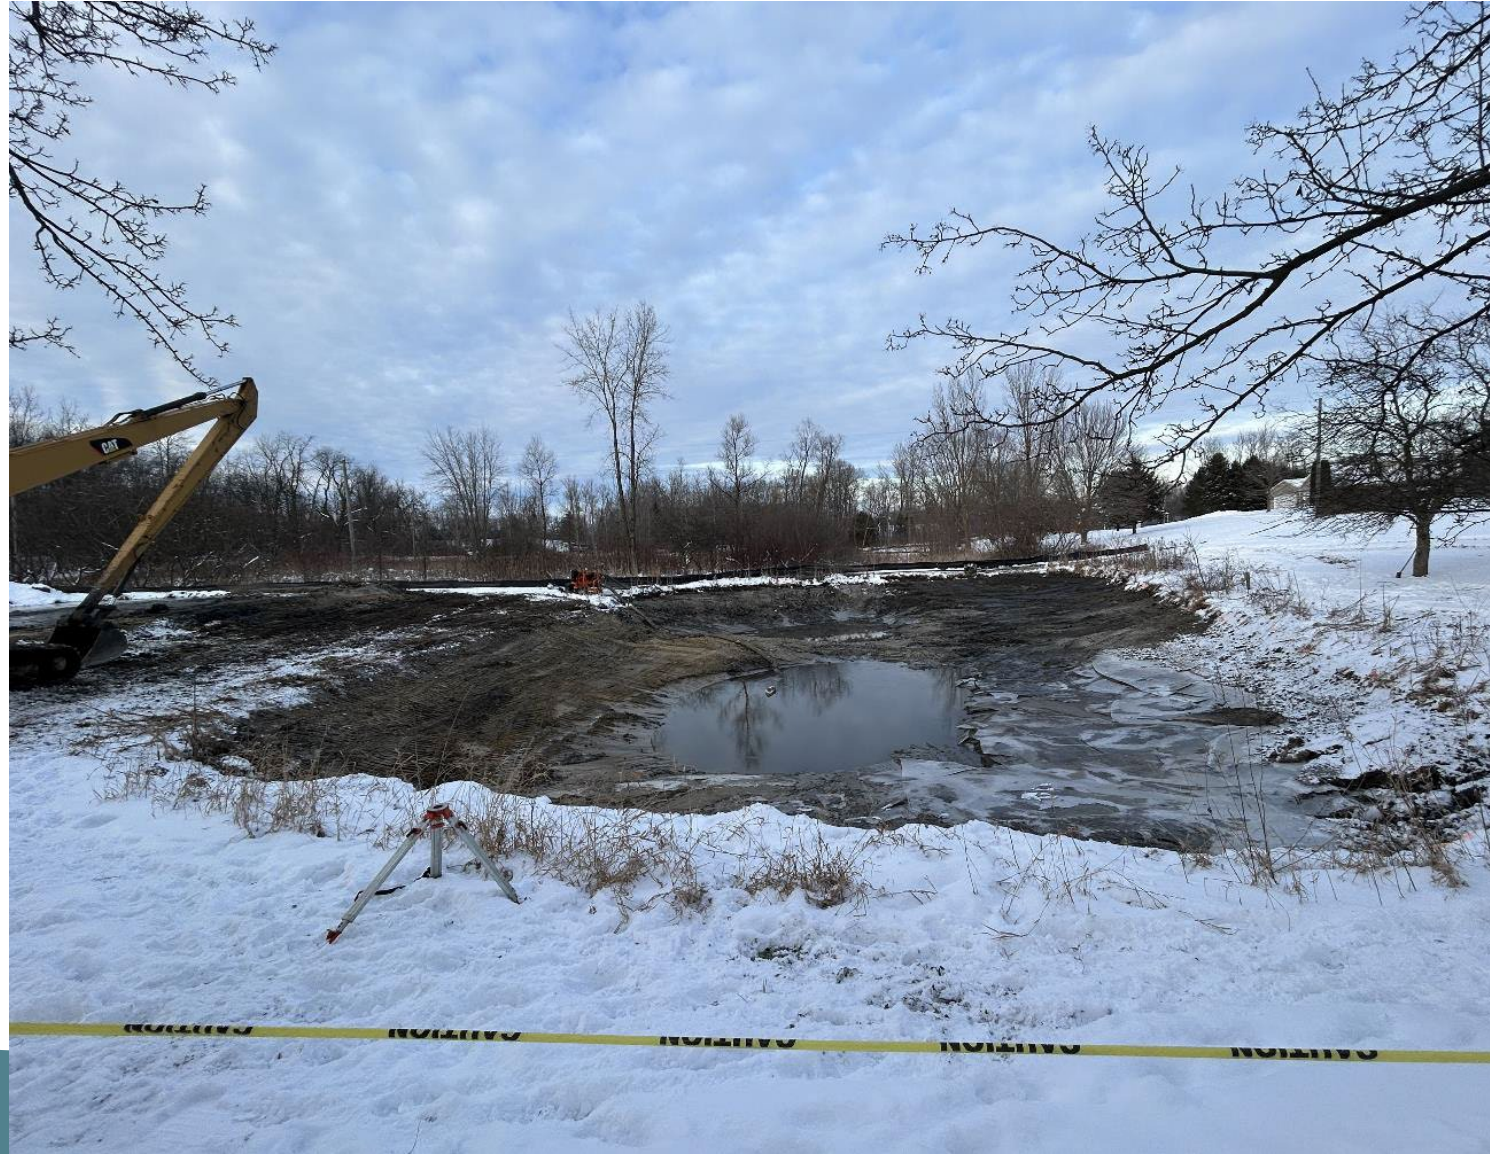
# Control/Eradication Methods

- Eradication through dredging, lining, and capping
- Dredging alone did not work (2-4 ft of sediment removed)
- Boom in hydrilla post dredging
- In process to redrain, line, and cap pond

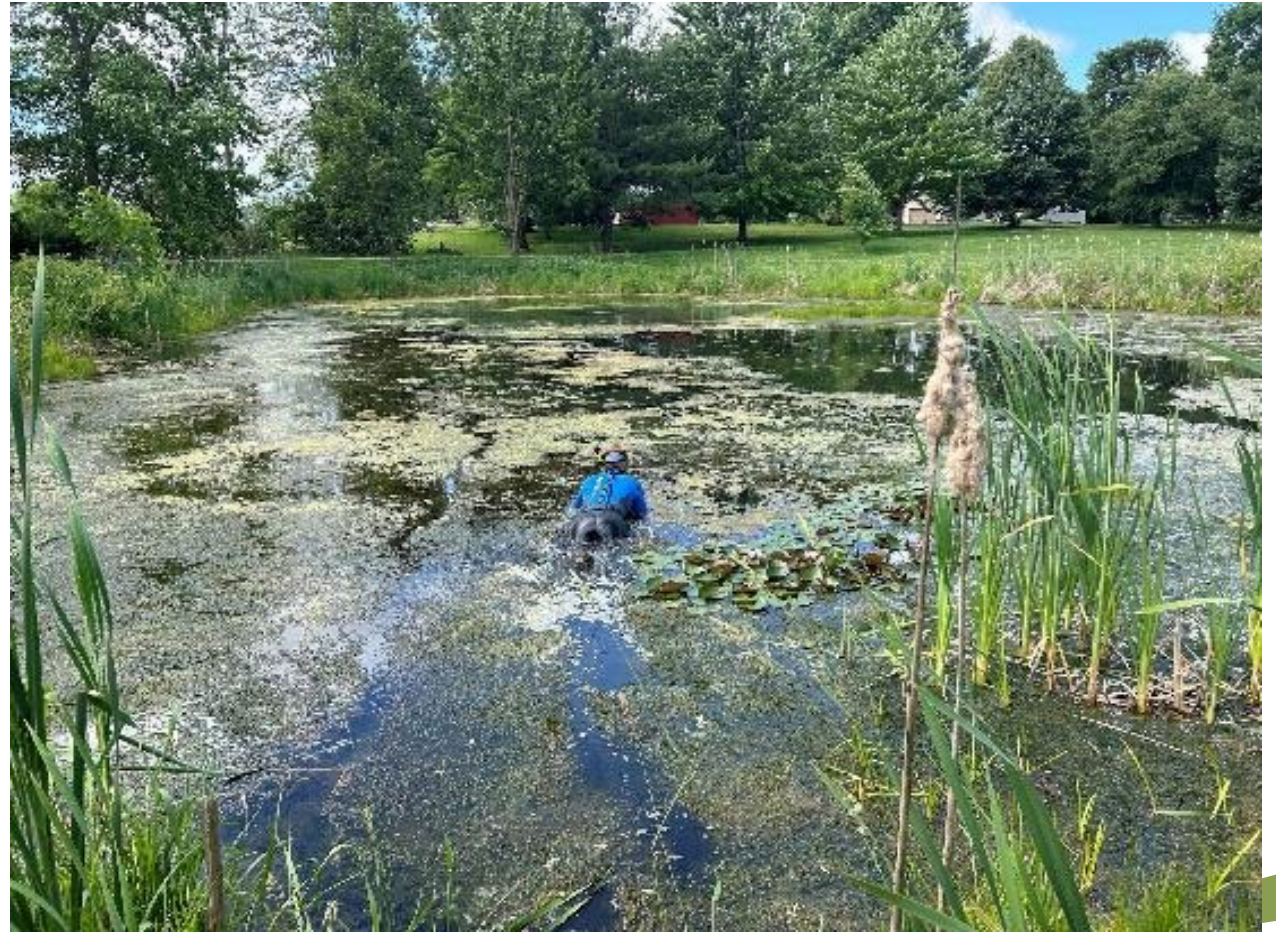
# Eradication Determination

- No hydrilla present for 3 years
- Monthly monitoring (snorkeling and wading)
